ACKNOWLEDGMENT OF COMPLETION REPORT

BNSF PANHANDLE DERAILMENT WEST OF INTERSECTION U.S. HIGHWAY 60 AND FARM-TO-MARKET 293E SPUR PANHANDLE, CARSON COUNTY, TEXAS

September 2016

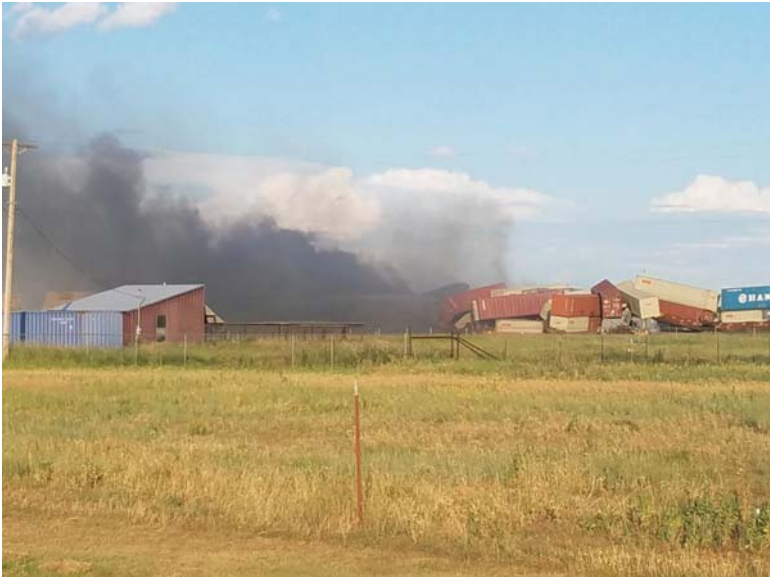
Incident Name: BNSF Train Collision
Event Name: BNSF Train Collision
Photo Type:
Direction:
Photo Name: 20160628_195404 2.jpg
Date and Time: Jun 28 2016 12:00AM
Latitude: 35.345967
Longitude: -101.372241
Photographer: 11682
Witness: TEDD
Caption:

Incident location - Point of impact - Railcars smoldering - Eastbound railcars

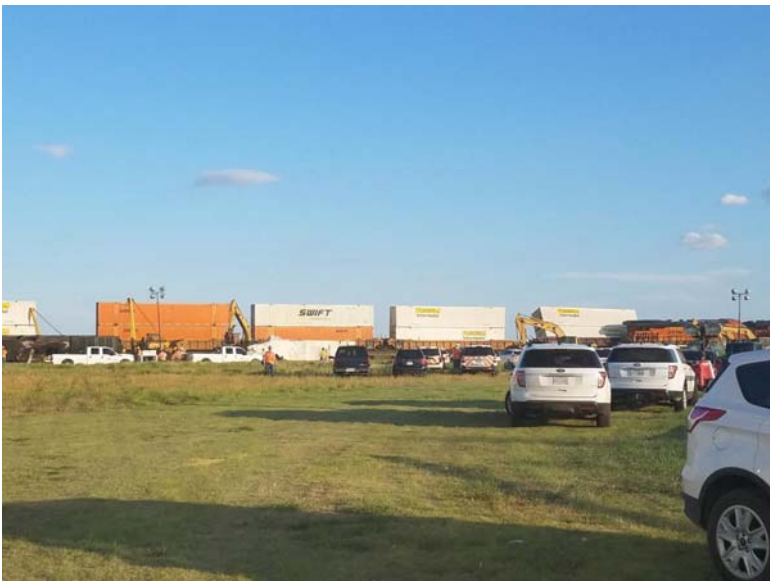
Incident Name: BNSF Train Collision
Event Name: BNSF Train Collision
Photo Type:
Direction:
Photo Name: 20160628_195632.jpg
Date and Time: Jun 28 2016 12:00AM
Latitude: 35.346779
Longitude: -101.368300
Photographer: 11682
Witness: TEDD
Caption:

Incident location - West bound railcars

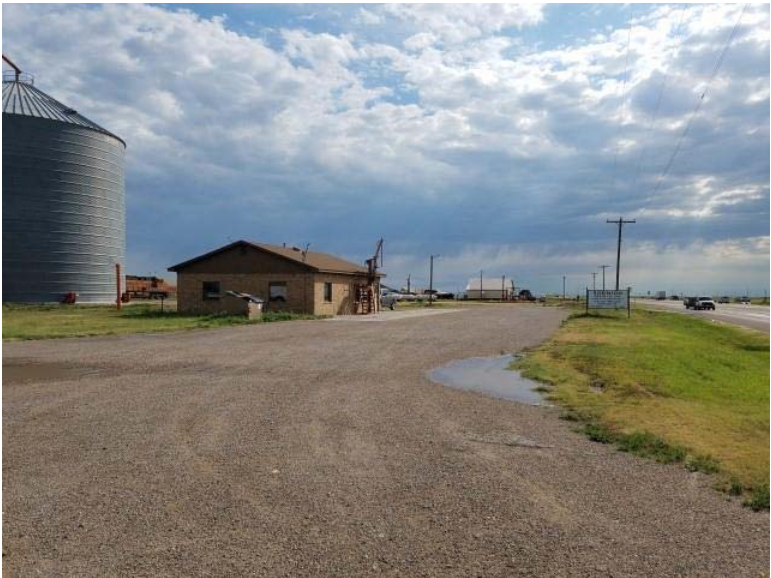
Incident Name: BNSF Train Collision
Event Name: BNSF Train Collision
Photo Type:
Direction:
Photo Name: 20160629_094041.jpg
Date and Time: Jun 29 2016 12:00AM
Latitude: 35.345581
Longitude: -101.366038
Photographer: 11682
Witness: TEDD
Caption: Point of Impact

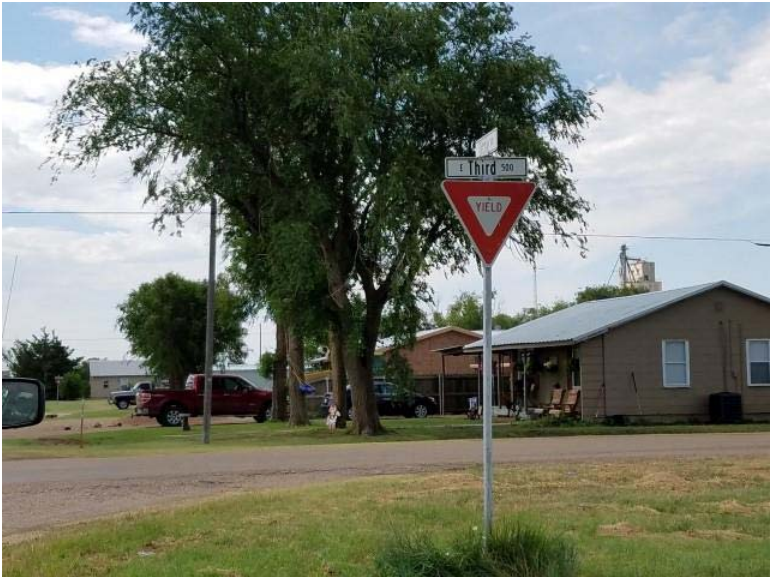
Incident Name: BNSF Train Collision
Event Name: BNSF Train Collision
Photo Type:
Direction:
Photo Name: 20160629_094040.jpg
Date and Time: Jun 29 2016 12:00AM
Latitude: 35.345581
Longitude: -101.366038
Photographer: 11682
Witness: TEDD
Caption: Point of Impact - West Bound Train

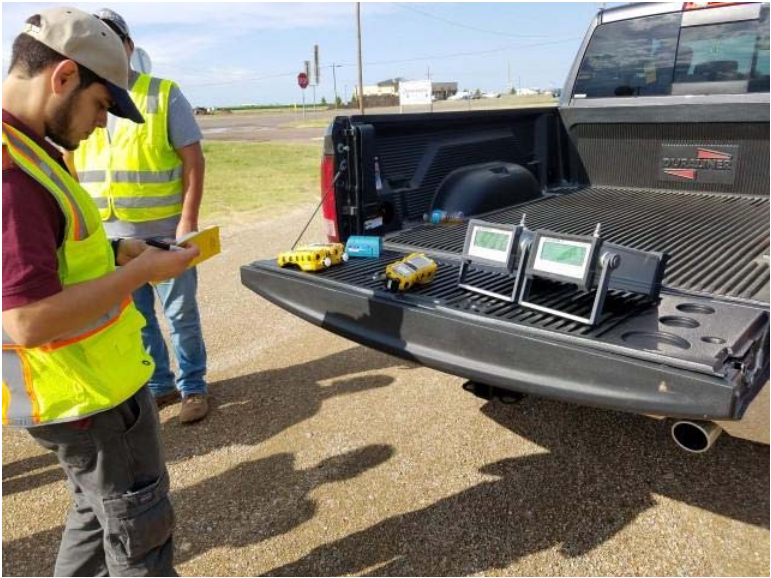
Incident Name: BNSF Train Collision
Event Name: BNSF Train Collision
Photo Type:
Direction:
Photo Name: 20160629_094032.jpg
Date and Time: Jun 29 2016 12:00AM
Latitude: 35.345581
Longitude: -101.366038
Photographer: 11682
Witness: TEDD
Caption: Point of Impact - West Bound Train

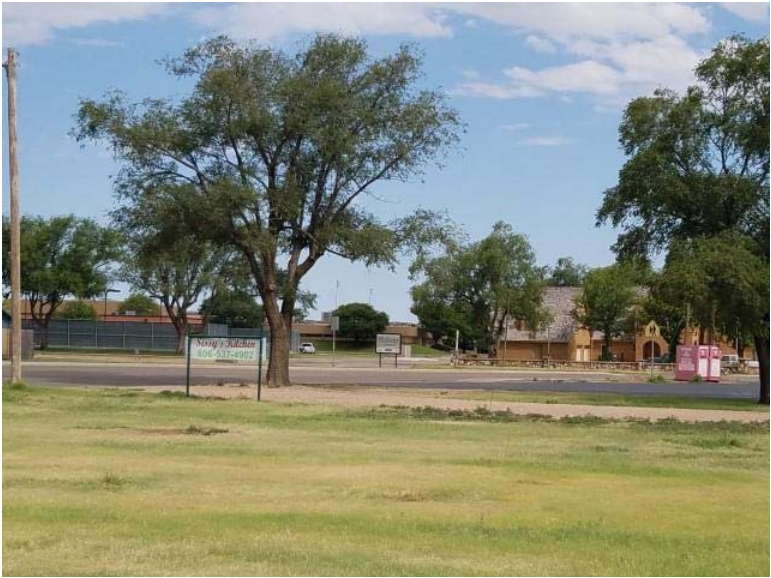
Incident Name: BNSF Train Collision
Event Name: BNSF Train Collision
Photo Type:
Direction:
Photo Name: 20160629_094039.jpg
Date and Time: Jun 29 2016 12:00AM
Latitude: 35.345581
Longitude: -101.366038
Photographer: 11682
Witness: TEDD
Caption: Point of Impact - West Bound Train
